## HOME INSPECTION REPORT

11 Mountain Drive

JP-smvl-2004-12-03

03 December 2004

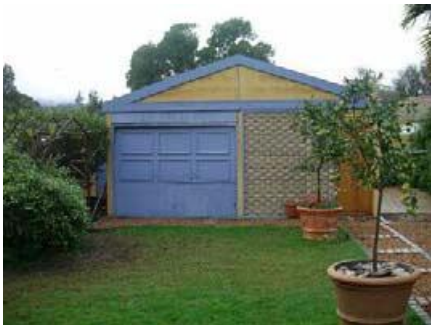
| Deck | | | Excellent | Good | Average | Poor | Very Poor |
|---|---|---|---|---|---|---|---|
| M <sup>2</sup> | 75 | NOTES | € Electronic garage door opener which offers direct access to house.<br>€ An extra garage door to back of property is also present.<br>€ (D) - Crack evident in garage walls- points towards structural defect. | | | | |

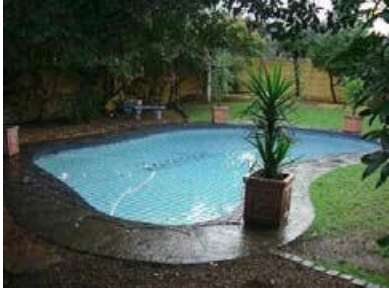
| Pool | | | | Excellent | Good | Average | Poor | Very Poor |

| Pool | | | | Excellent | Good | Average | Poor | Very Poor |
|---|---|---|---|---|---|---|---|---|
| | | | Pool Structure | | | | | å(D) |

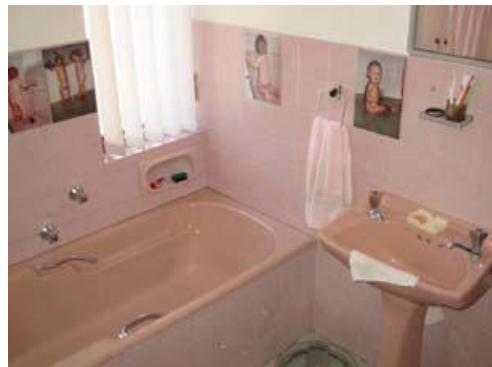
| GRANNY FLAT | | | | | | | |
|---|---|---|---|---|---|---|---|
| Bathroom | | | Excellent | Good | Average | Poor | Very Poor |

| GRANNY FLAT | | | | | | | |
|---|---|---|---|---|---|---|---|
| M ² | 15 | NOTES | € (D) – Defect noted regarding the ceiling. | | | | |

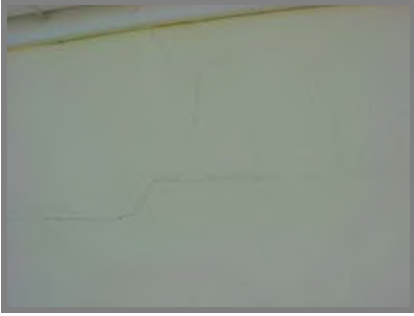
| <b><u>Defect(s) Assessment</u></b> | | | |
|---|---|---|---|
| Garage | Description of defect(s) | å MINOR | å MAJOR |

| <b><u>Defect(s) Assessment</u></b> | | | |
|---|---|---|---|
| | Cracks evident- indicating structural problems. | | å |

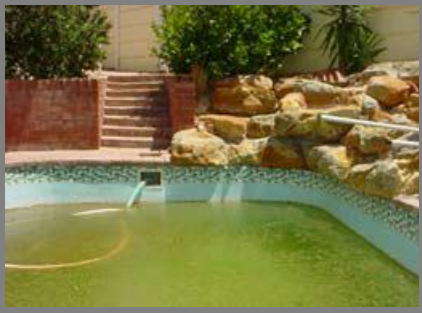
| <b><u>Defect(s) Assessment</u></b> | | | |
|---|---|---|---|
| Pool | | | |

| <b><u>Defect(s) Assessment</u></b> | | | |
|---|---|---|---|
| | Damaged swimming pool (water level shows sagging pool structure) | å | |

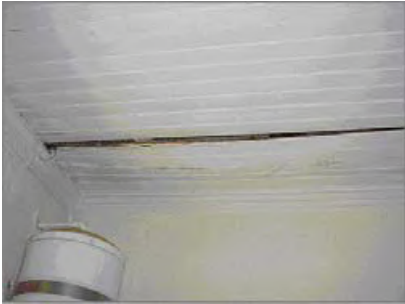
| <b><u>Defect(s) Assessment</u></b> | | | |
|---|---|---|---|
| Bathroom in Granny Flat | | | |

| <b><u>Defect(s) Assessment</u></b> | | | |
|---|---|---|---|
| | Sagging and water damage to ceiling | å | |
