## HOME INSPECTION REPORT

11 Mountain Drive

JP-smvl-2004-12-03

03 December 2004

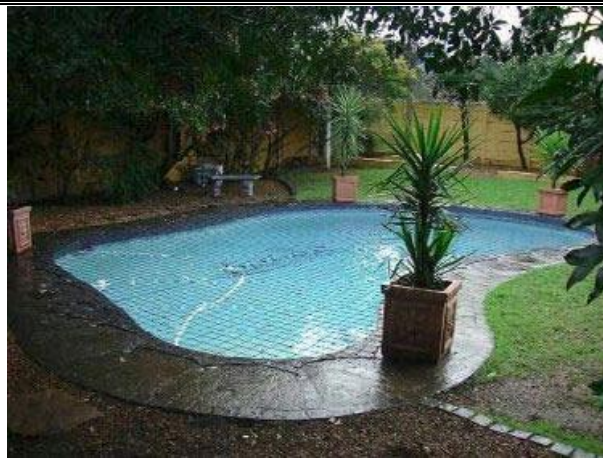
Pool

| <b><u>Defect(s) Assessment</u></b> | | | |
|---|---|---|---|
| | Damaged swimming pool (water level shows sagging pool structure) | å | |

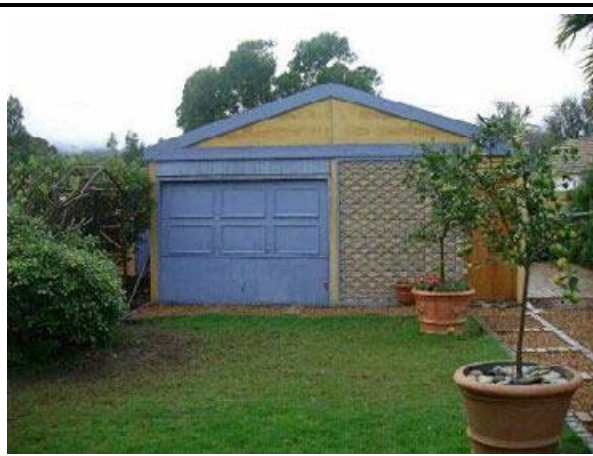
Garage

| Deck | | | Excellent | Good | Average | Poor | Very Poor |
|---|---|---|---|---|---|---|---|
| M <sup>2</sup> | 75 | NOTES | € Electronic garage door opener which offers direct access to house.<br>€ An extra garage door to back of property is also present.<br>€ (D) - Crack evident in garage walls- points towards structural defect. | | | | |

| <b><u>Defect(s) Assessment</u></b> | | | |
|---|---|---|---|
| | Cracks evident- indicating structural problems. | | å |
